NASA/TM-2005-213750/Version 1.0
NESC-RP-05-18

Space Shuttle Orbiter Reaction Jet Driver (RJD)

Independent Technical Assessment/Inspection (ITA/I) Report

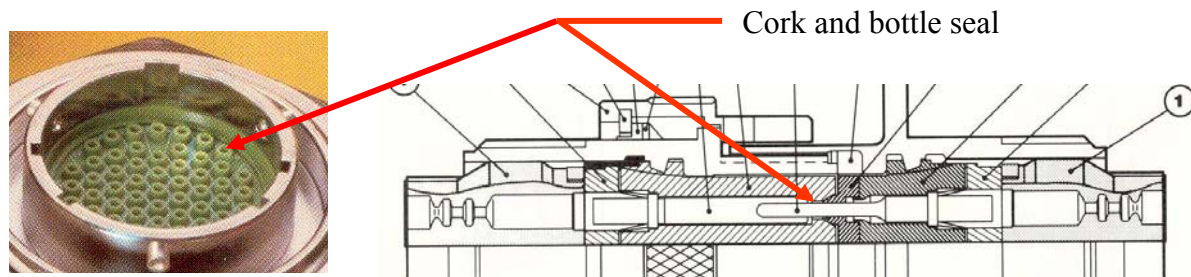
Figure 7.2.3-1. Back Shell Short via Wire Braid Strand, Metal Chip Contamination Considered Remote Due to Connector “Cork and Bottle” Interfacial Seal

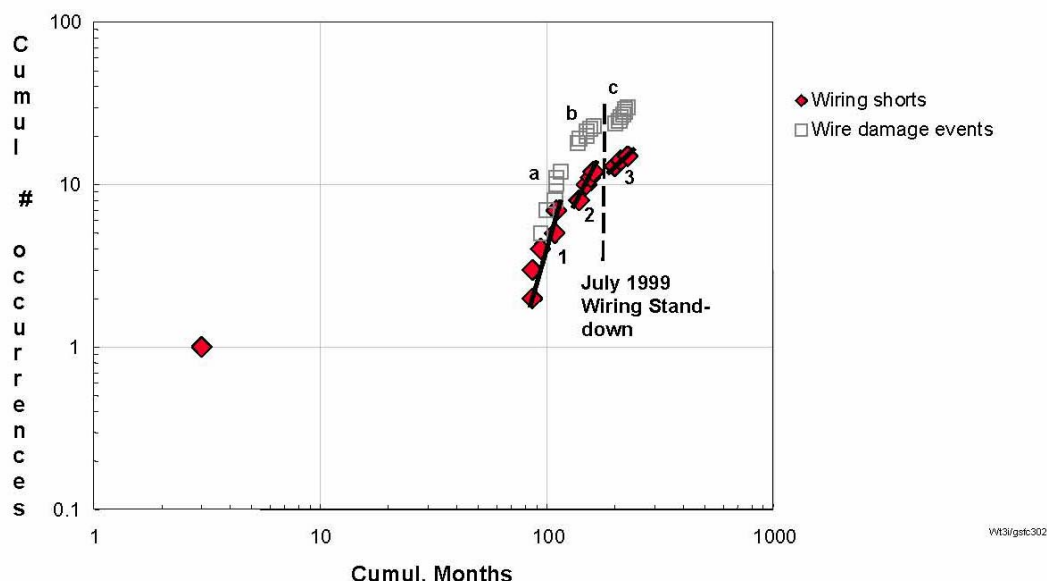
Figure 7.3.1-1. Crow-AMSAA Plot of STS Orbiter Interconnect Short Circuits

The Orbiter wiring short data indicate that wiring shorts may be worsening with time. These data suggest that wire degradation does exist in the Orbiter. More detailed analyses should be

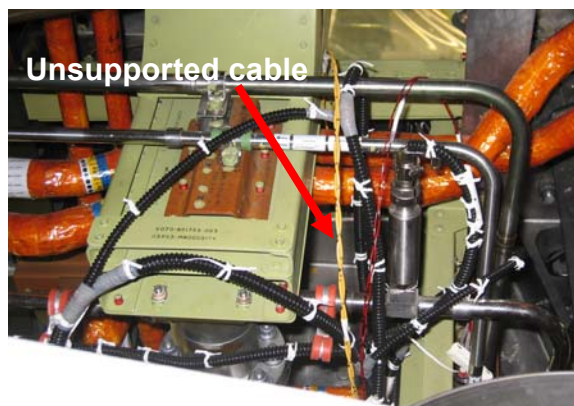
Aft bay

- F-3. Unprotected wire bundles resting on bracket edges in upper equipment wiring area violates NSTS 8080-1 Std. 142, p. 3-285.
- F-4. Teflon-insulated wires contacting sharp corners within the RJD box violates the NSTS 8080-1 Std., 142, p. 3-285 (Figure 8.1-2).
